SERVICE BULLETIN: JSB 019-2
Issue: 2
Date: 24th November 2010
Subject: Control Surface Clearance

Jabiru Service Bulletin: Control Surface Clearance

JSB 019-2

24th November 2010

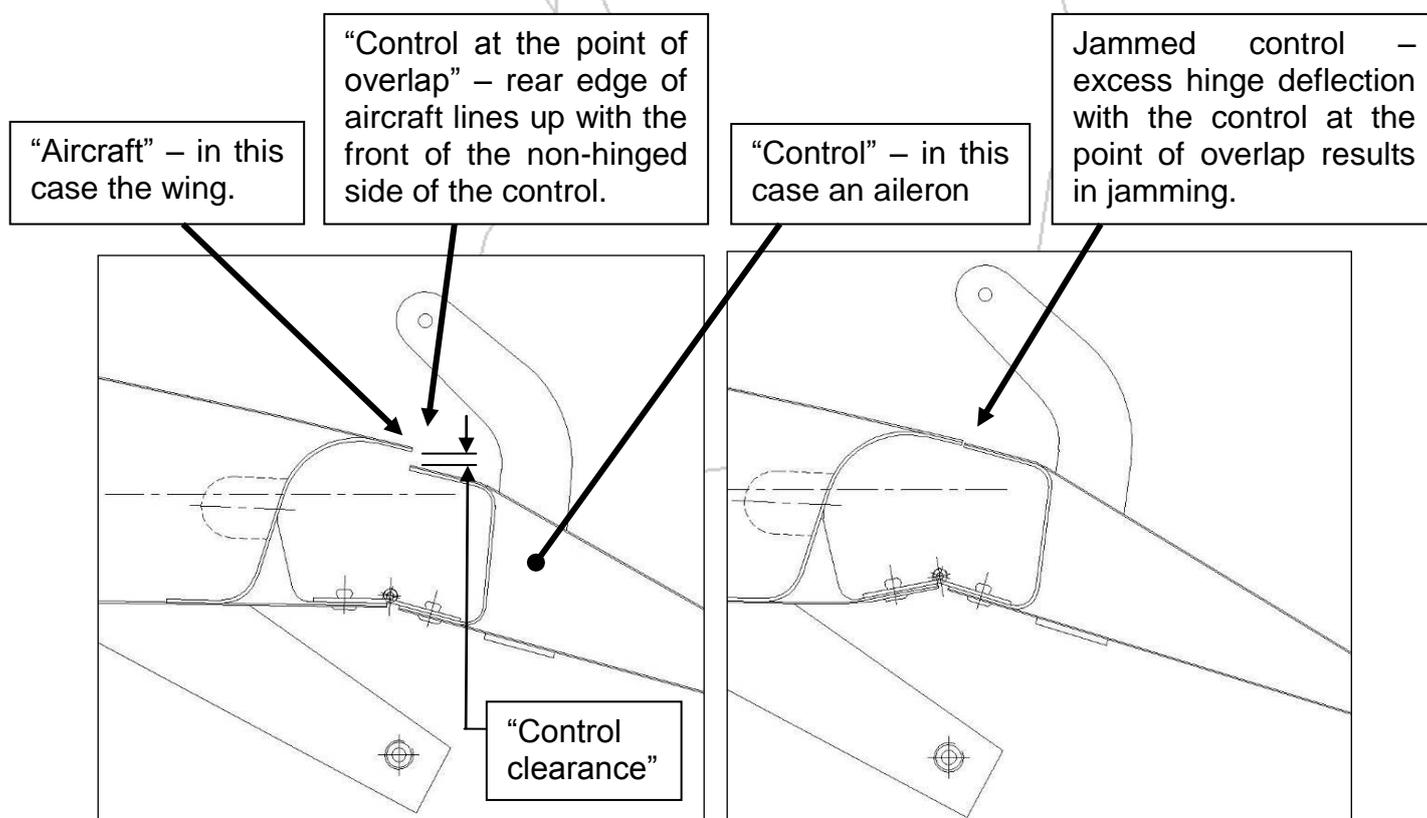
Figure 1 – Normal and Jammed Control Illustration

- In early 2008 this bulletin was first released to address several cases where the control surfaces of Jabiru Aircraft have rubbed against fixed parts of the airframe during flight. In some cases this lead to the control jamming. Figure 1 illustrates a typical control in both the normal (shown at left) and jammed (shown at right) positions.
- Since this bulletin was first released these incidents have continued to occur, though at a lower rate. In some cases these incidents have lead to a loss of control of the aircraft, resulting in significant damage.

- **Control** – This refers to control surfaces – rudder, elevator and ailerons.
- **Aircraft** – This refers to the fixed part of the aircraft immediately in front of the controls. In particular it refers to the point indicated in Figure 1, where the control will hit the aircraft if a jam occurs.

- **Control at the point of overlap** – This is the particular point where the rearmost edge of the aircraft is aligned with the front of the non-hinged side of the control. This is the critical point where a control jam becomes possible. Any control which has a critical overlap of less than 2mm should also be treated as having a “point of overlap” as defined by this bulletin.

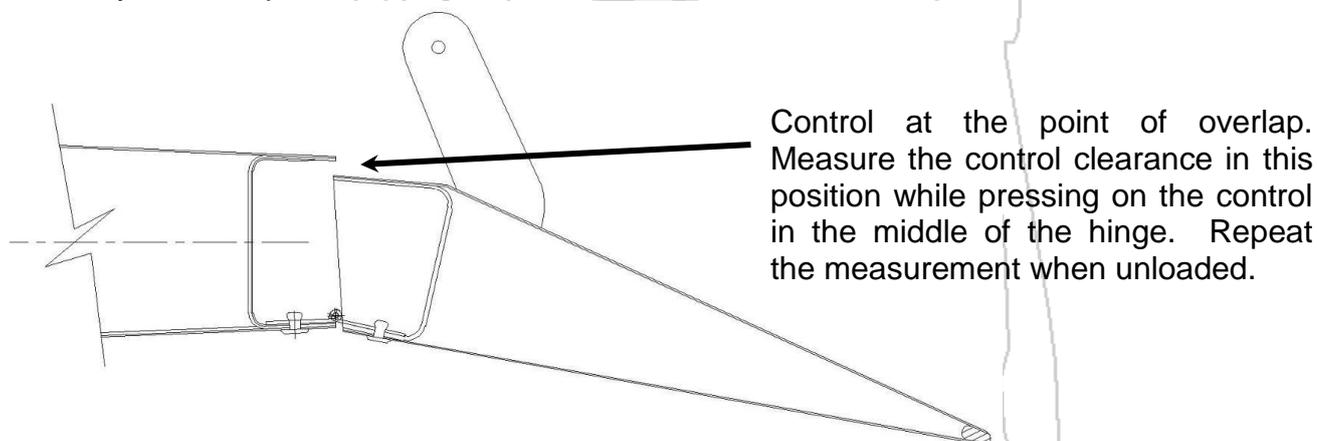
Figure 2 – Rudder Gap Cross Section

- **Control clearance** – This is the working clearance between the control and the aircraft.
- **Control gap** – Best shown on Figure 3 (left). If the control passes the point of overlap a gap opens between the aircraft and the control. A gap like this combined with excess flexing of the control surface hinges will lead to control surface jamming.

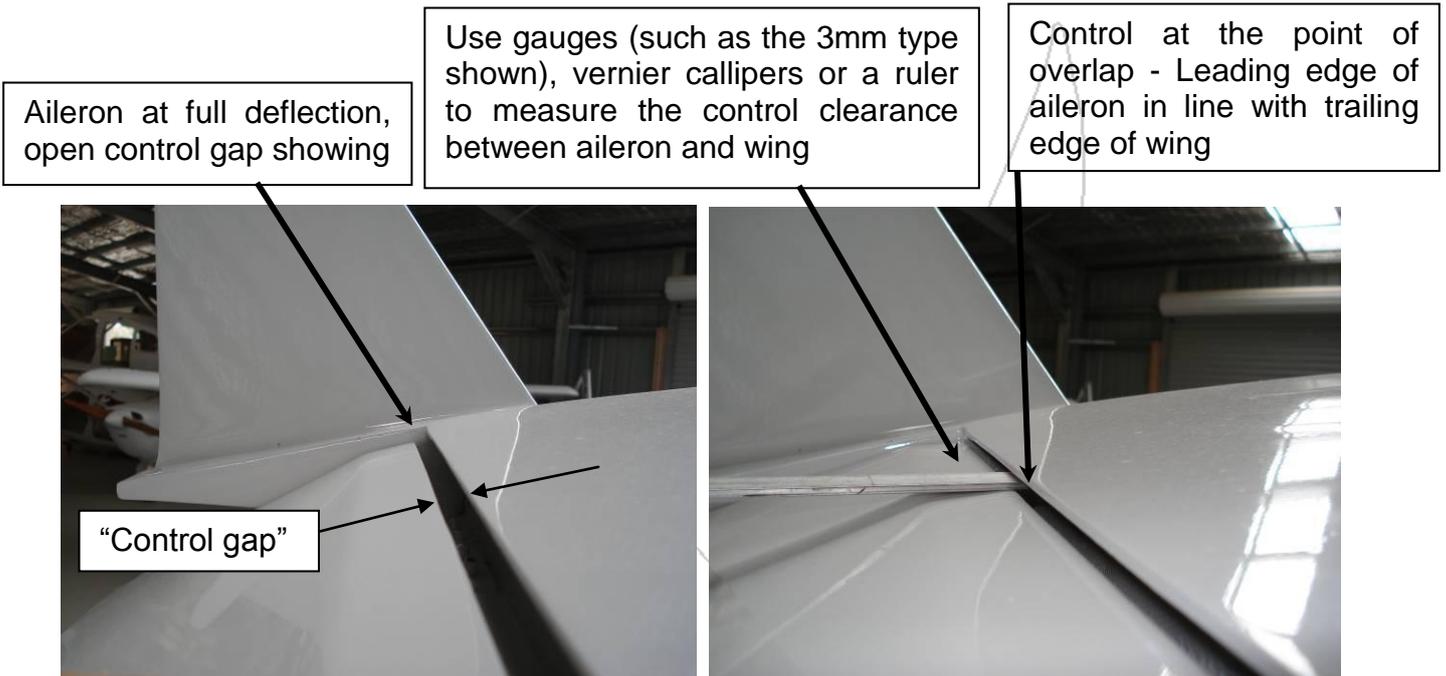
Figure 3 – Aileron Clearance

- This inspection is to check if the controls are configured in such a way that there is a point of overlap as shown in Figure 1. At noted above the point of overlap is the critical point at which severe control jamming becomes possible.
- Check each control by moving it to its maximum deflection and inspecting for a control gap – as shown in the example of Figure 3.
- Note the result of Inspection A and carry on to Inspection B in all cases.

- Check the clearance between the control surface and the aircraft at the point of overlap as detailed below:
 1. Set the controls so that the control being tested is at the point of overlap – as shown in the right picture in Figure 3. If the control being tested does not deflect to a point of overlap then place it as close as possible to the overlap point.

- 5. **Rectification work is necessary whenever any of the following criteria are met:**
 - The control clearance is less than 3mm at the control's point of overlap when tested as detailed in Inspection B. Note that this clearance limit only applies to controls which are configured such that they actually have a point of overlap.

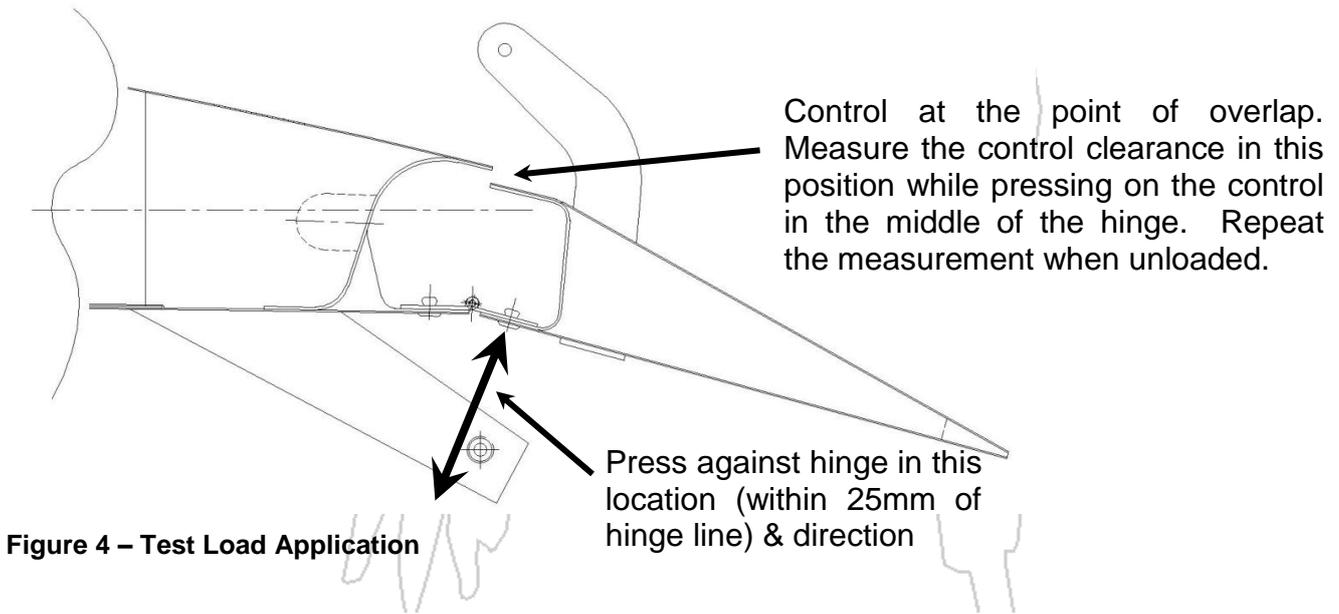
Figure 4 – Test Load Application

3. Remove the load from the control and re-measure the control clearance.
 4. Controls are to be tested this way at every hinge. The force to be applied in each direction is approximately 5-7kg (11 – 15lb). Inspectors can “calibrate” their thumbs by pushing onto a set of scales to indicate how hard they need to push. See Figure 4 for details of where to push on the controls.

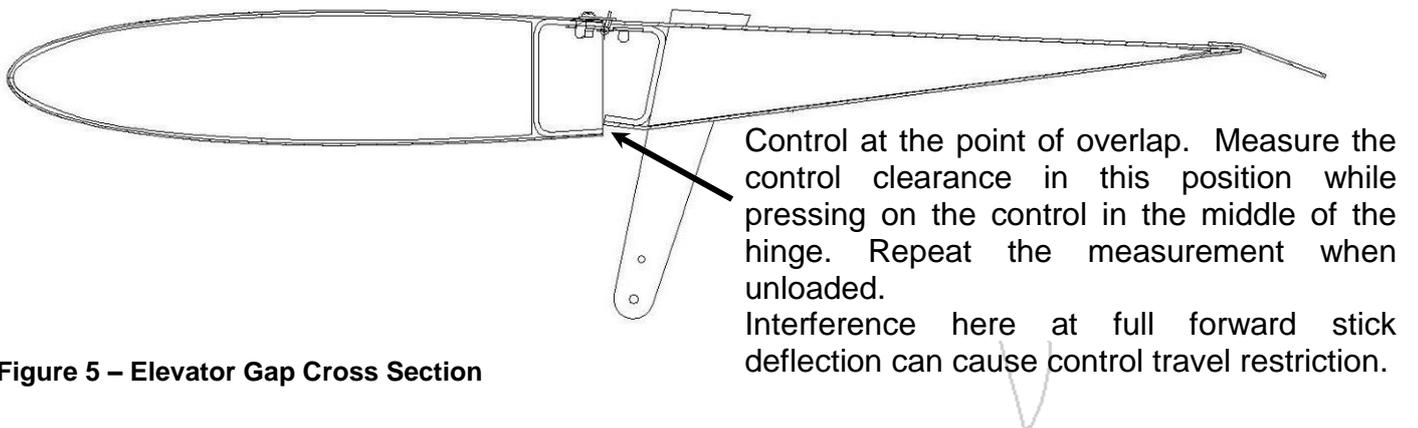
Figure 5 – Elevator Gap Cross Section

- Travel restriction normally presents at the opposite control travel extreme to the control's point of overlap – i.e. for the elevator shown above (Figure 5) full stick-forward deflection is the point most likely to exhibit a travel restriction as the lower surface of the elevator hits the aircraft.

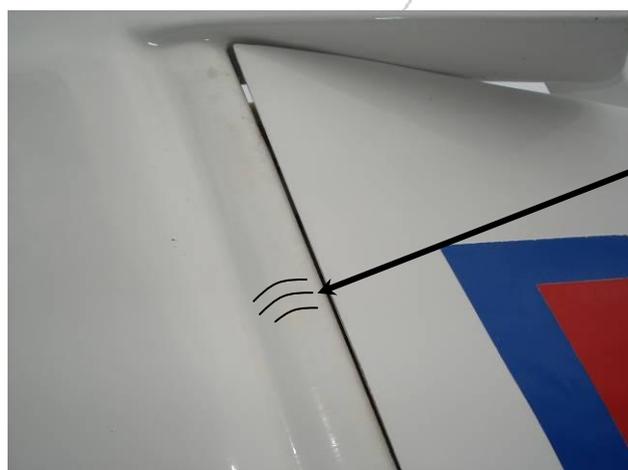
Figure 6 – Scratches on Rudder

- Inspect each control as detailed below:
 1. Inspect the control for scratches and marks (as shown in Figure 6) in the overlap area where the control runs inside the aircraft. If no marks are found further inspection and/or rectification is unnecessary. However, if such marks are found complete the following steps:

Scratches here indicate the control has rubbed against the fin (illustration)

- There is travel restriction caused by the control rubbing against the aircraft.
