SERVICE BULLETIN: JSB031

Issue: 3

Subject: Engine Through Bolt Replacement and Upgrade

Affected Models: Jabiru 2200 & 3300 Engines in FLIGHT TRAINING

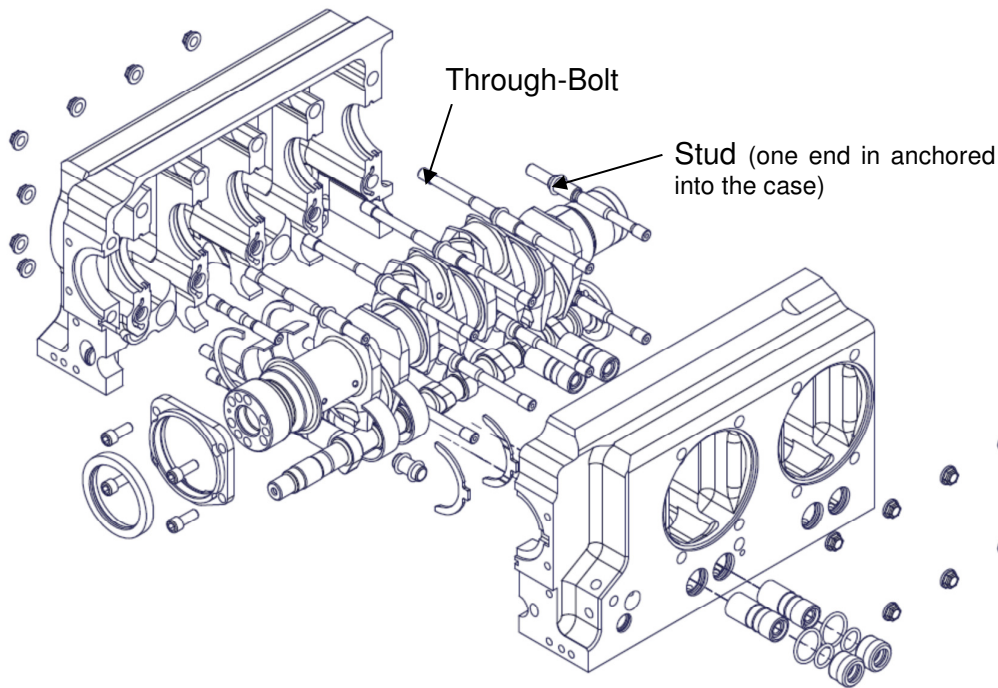
Figure 1 – General Engine Layout

- Jabiru Engines are assembled using a combination of Through-Bolts and Studs – as shown in Figure 1 below. The number of through-bolts varies depending on which engine model is considered but there are always 6 studs (not all with the same part number). The through-bolts and studs hold the cylinders in place and the halves of the crankcases together.

- There have been some cases of these bolts failing in service, leading to engine failure.
- In April 2011 JSB031 Issue 1 was issued. This bulletin detailed then-current inspections and alterations required to correct this potential unsafe condition with the through-bolt hardware of certain Jabiru 2200 and 3300 engines.

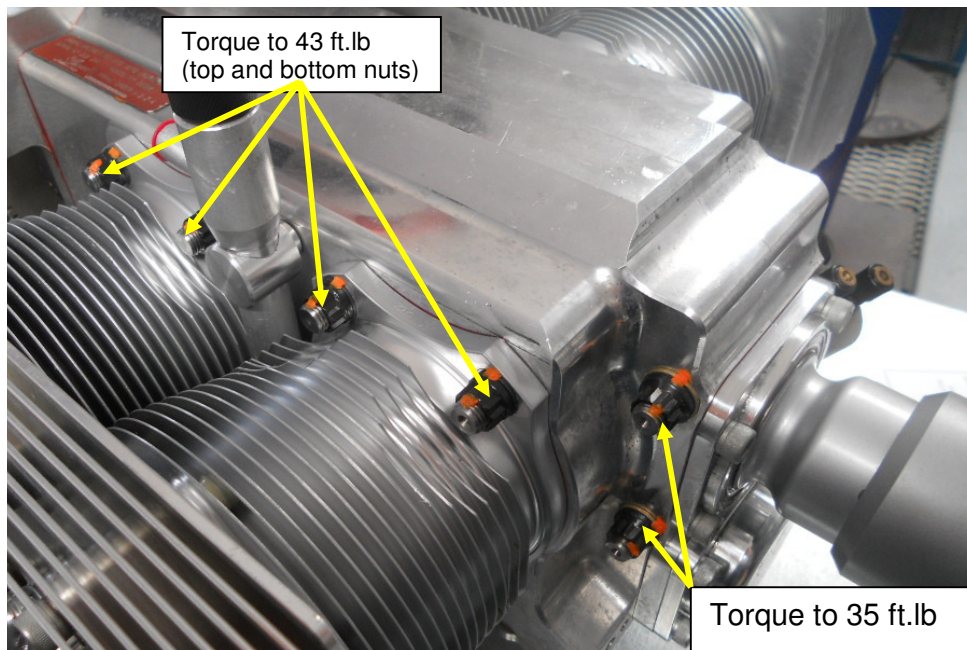
Figure 2: Bolt torques.

At the next 25hrly service, check the torque setting of 12 point nuts with a calibrated torque wrench. Prior to checking the torque, conduct crankshaft friction test as per section 6.2. If the torque was found to be less than 43 ft/lbs they should be retorqued to 43 ft lbs, if they are less than 43 ft lb. Reapply torque seal. Please see Figure 2.

When re torquing the through bolts, to ensure that the torque value is accurate, the bolts have to be loosened by ¼ of a turn before torqueing up again. There must not be any locking compound on these bolts/nuts, if there is any indication of locking compound the nuts must be removed and the threads cleaned, then re-installed as per the section below. Loctite prevents the correct bolt tension from being achieved and the torque being checked.

Only loosen and change the nuts/washers on one bolt at a time. Then torque to 43 ft lb before undoing the next bolt. This will avoid losing too much clamping force of the case. If a locking compound was used on the bolt/nuts, threads must be cleaned before nuts are refitted. Once all bolts are done check the torques and apply torque seal. Please see Figure 2.
