SERVICE LETTER: JSL019

Subject: Rudder Cable End Inspection.

Affected Models: All Jabiru Airframes.

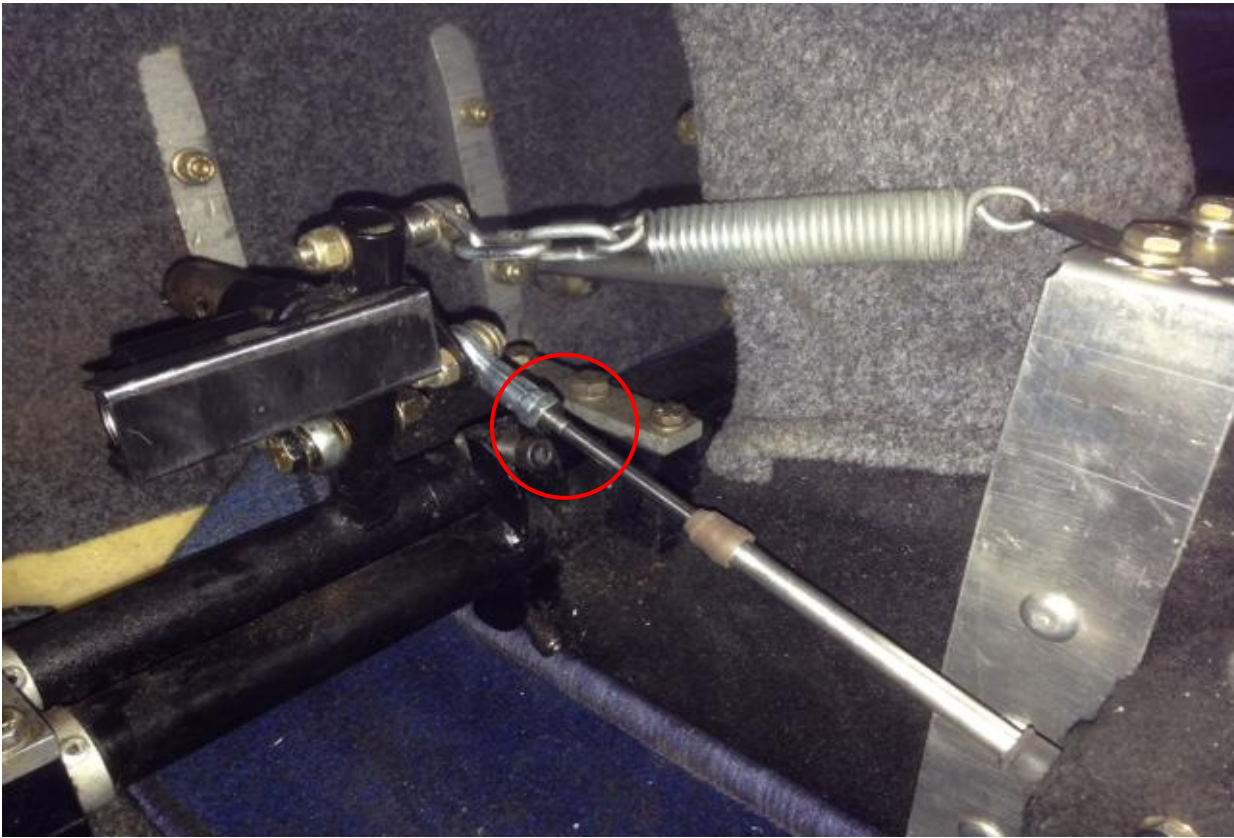
- A single incident involving the precautionary landing of a Jabiru aircraft has highlighted a condition which can potentially lead to an in-flight loss of rudder control.
- On inspection, by the operator, it was found that the rudder cable had broken.
- Jabiru inspected the parts and have found that the cable end had been bent before it failed.
- This service letter has been prepared to inform operators and maintainers of Jabiru Aircraft of this condition.

Figure 1 – Location where cable broke.

- All Jabiru Aircraft use a push pull type rudder cable. The end of the cable is fitted with a rod end, for attachment to rudder pedals. **The factory installation has proven to be suitably robust in service.** (1 confirmed instance for over 8,000 cables in service)
- The only likely cause of the cable being bent, in this instance, is force applied by a pilot's foot. The bend was in the horizontal plane. Investigation revealed that a large amount of force was required at an awkward angle.
- The rudder cable end is stainless steel so once bent only a small number of push pull cycles are needed to cause it to break.
- Cable end condition need to be checked during daily inspection, as with other external cable ends.

- The Jabiru Airframe Technical Manual (JTM001) contains requirements for the maintenance of control cables and rod ends (always refer to the most recent revision of these documents).
- Rudder pedal linkages and cables ends are inspected every 100hrs.

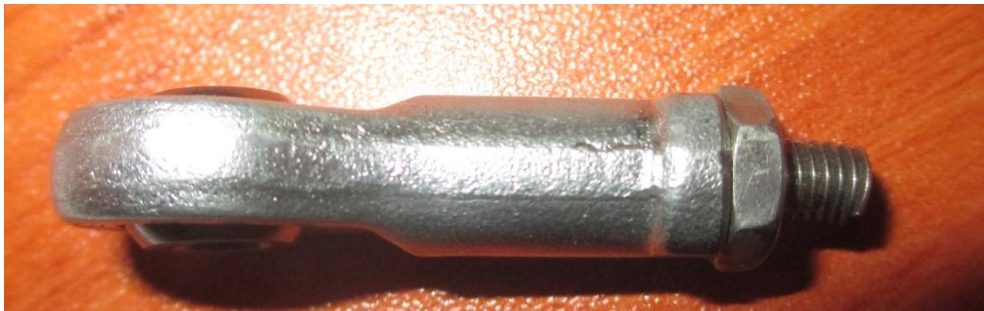
Figure 2: Rod end with broken end of cable.

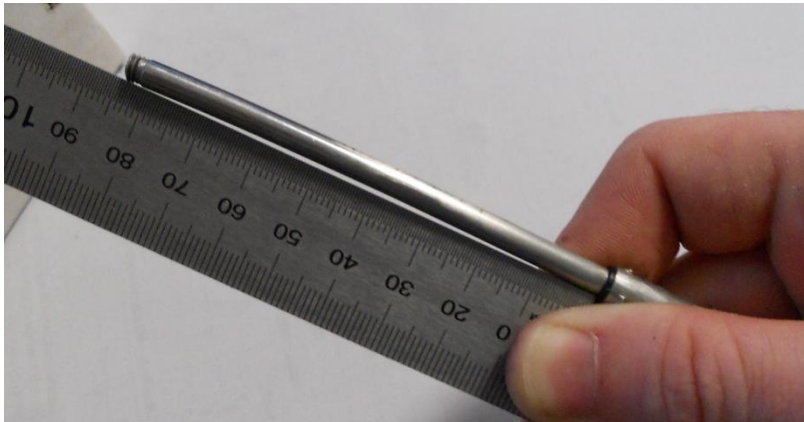
Figure 3: Cable end.
