# JABIRU AIRCRAFT PTY LTD

## SERVICE BULLETIN: JSB 022-2

Subject: Propeller Flange Attachment

# Jabiru Service Bulletin: Propeller Flange Attachment

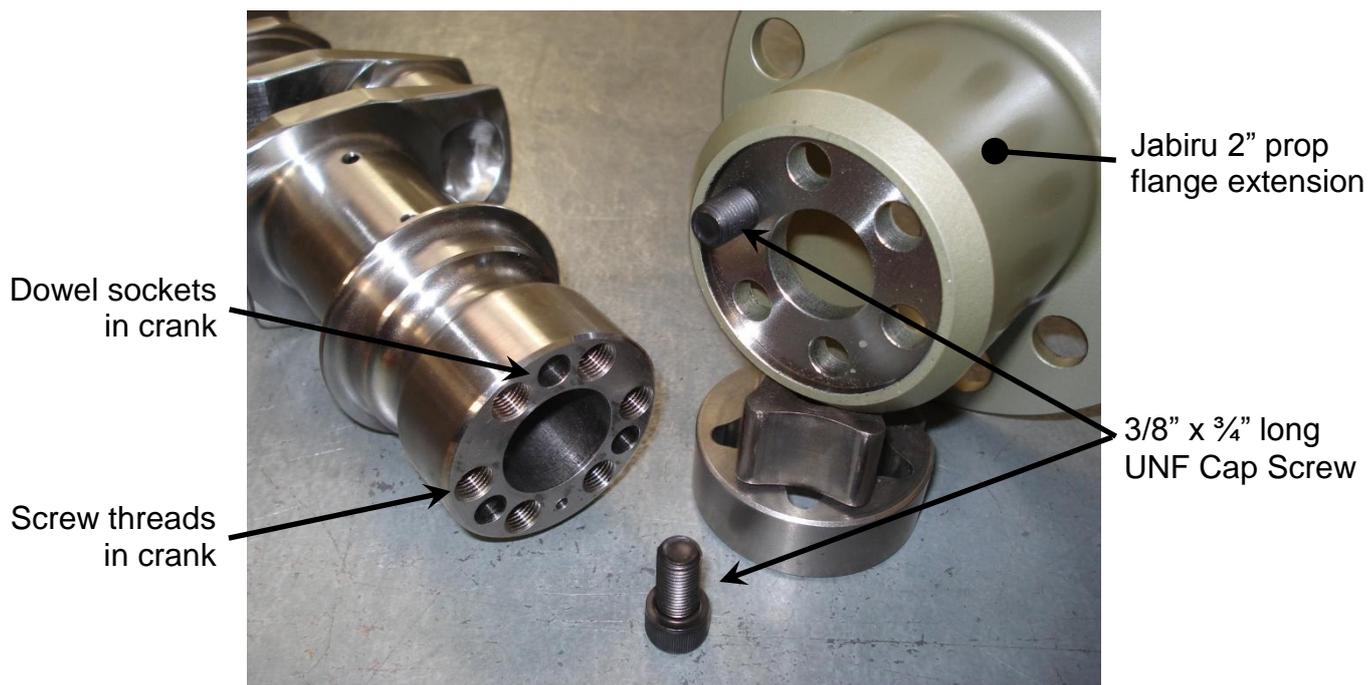
Figure 1 – Flange & Crankshaft

- c) Hold the propeller flange to the front face of the crankshaft. Ensure that the flange fits cleanly. Note that the socket of Jabiru propeller flanges are not designed to be a high-tolerance tight fit onto the end of the crankshaft – a small amount of clearance is normal here.

- Dowel holes are drilled in the crankshaft for use by aftermarket propeller manufacturers (Ø8.00mm x 12 deep, PCD 41.5mm).
- Only propeller flanges made by Jabiru Aircraft or other approved manufacturers must be used. High quality machining with close tolerances is required to ensure the flange fits properly and the propeller runs true.
