JABIRU AIRCRAFT PTY LTD

SERVICE BULLETIN: JSB 027-1
Issue: 1
Date: 1st July 2009
Subject: Control Cable Clamp Inspection (Kit Models)

Jabiru Service Bulletin: Control Cable Clamp Inspection (Kit Models)

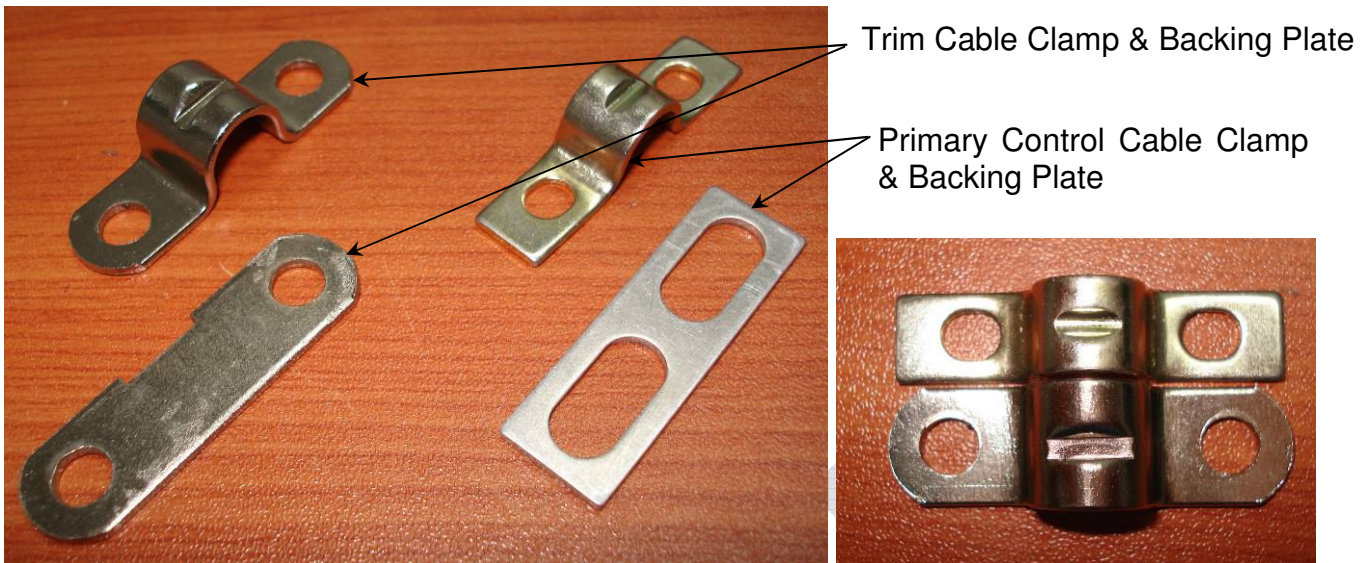
Figure 1 – Clamp Comparison (Primary Cable Clamp Upper on Right Picture)

Trim Cable Clamp
(note that it is larger than primary control cable clamp)

Primary Control Cable Clamp
(note square corner of clamp)

- The Figures below show various pictures of the cable clamps and cable assemblies. Points to note include:
 - i. Primary cables are have a green sheath with machined end fittings.
 - ii. Trim cables have black sheath with a visible crimp on the end fitting.
 - iii. Primary cable clamps are smaller than trim cable clamps and have square corners.
 - iv. Primary cable backing plates are smaller, have a slotted hole and are made from aluminium.
 - v. The two cables are made by different manufacturers and the clamps are supplied by each manufacturer to suit. **The correct type of clamp must be used with each cable.**
 - vi. The rubber seal of primary control cables must be pulled back slightly to allow the clamps to be installed properly.
- Both cables use clamps which work by the same means: the clamp has a locking tang which inserts into a groove machined in the cable end fitting.

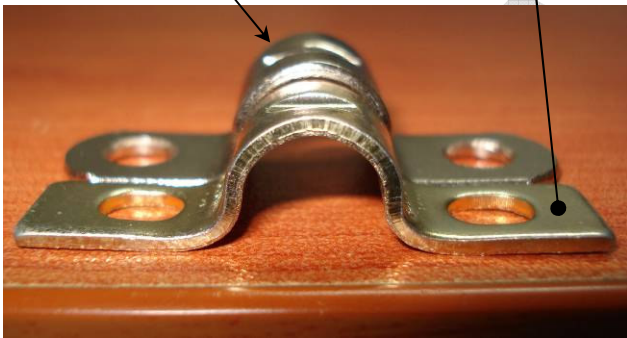
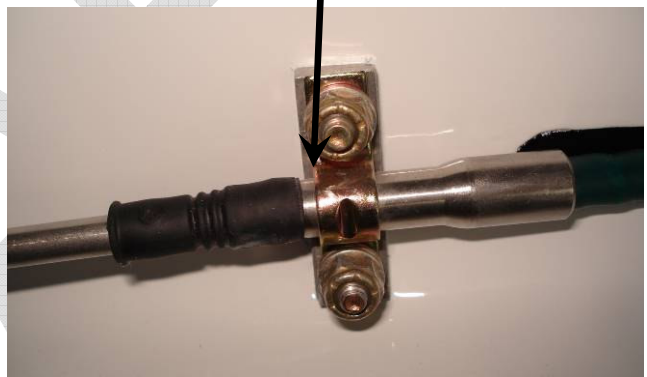
Figure 2 – Clamp Comparison & Installation (Rudder Cable)

Rudder cable clamp properly installed.
Note seal pulled back slightly

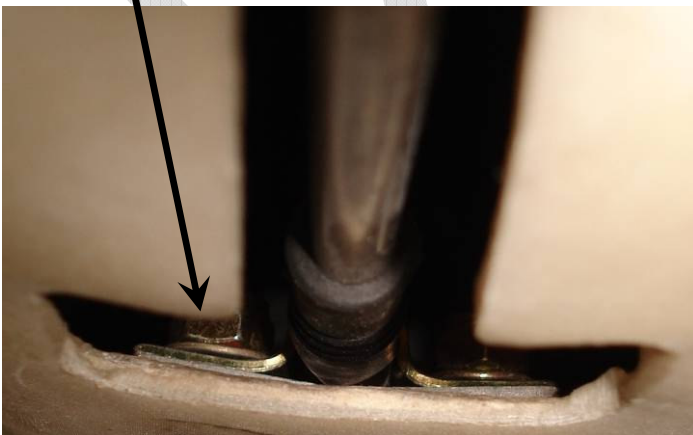
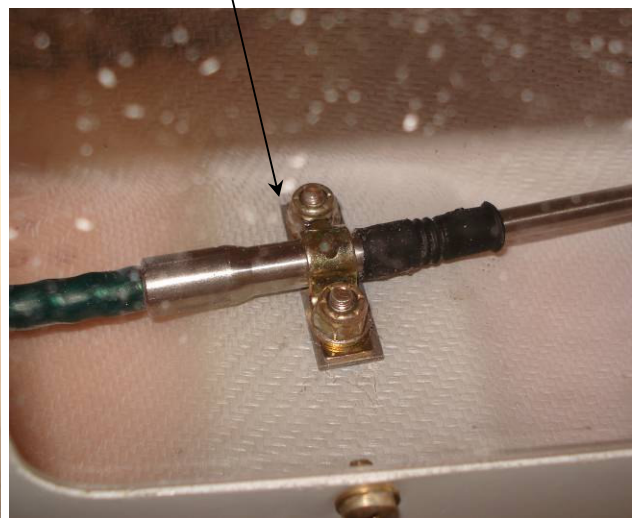
Figure 3 – Clamp Installations (Elevator & Aileron)

Elevator cable clamp properly installed.

Aileron cable clamp properly installed
(viewed through inspection window).

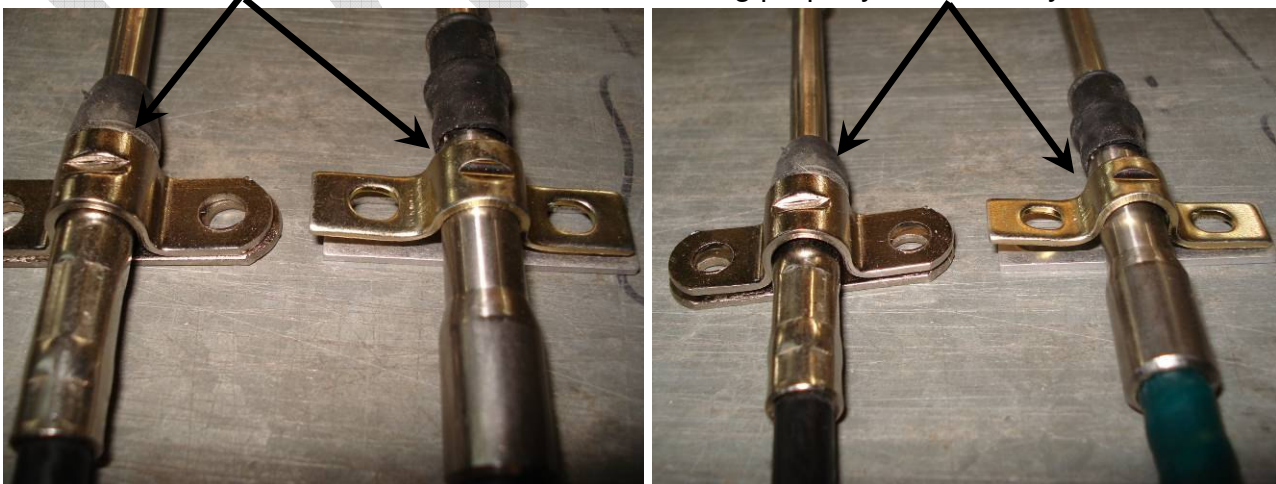
Figure 6 – Correct and Incorrect Clamp Installation

Clamps correctly assembled. Locking tangs correctly fitted, clamp fitting snugly around body of cable.

Clamps incorrectly assembled. Locking tangs misaligned, clamp not fitting properly around body of cable.

- Visually inspect each cable clamp fitted to the aircraft.
 - i. Ensure the correct type of clamp is fitted.
 - ii. Ensure the clamp is located correctly – i.e. directly over the locking slot in the cable end.

- iii. Ensure each clamp is correctly installed with the clamp tang engaging fully with the cable end fitting. Note that in some cases this may require the use of mirrors, torches etc to see enough angles of the clamp installation.

- iv. Ensure clamp bolt grip length is correct (i.e. the nut is not bottoming out or out of safety) and that the cable is firmly held together and firmly held against the structure.

- v. Ensure the clamps and mounting hardware are in good condition – no rust etc.
- Manually check that each clamp is firm – such as by gripping the end of the fixed section of the cable and pulling it back and forth while watching for movement. The inspector must also work the control surface through it's full range of motion, checking for looseness in the clamp assembly.
